**Meeting Paper**

**Corrosion Protection of Steel  
Pipelines in Brine Service by  
Internal Concrete Liners**

Fall 1998 Meeting  
Rome, Italy  
4-7 October 1998

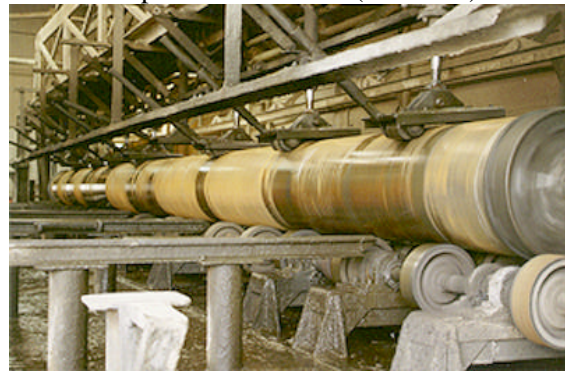
**Figure 1.** Centrifugal application of an internal concrete liner at Permian Enterprises, Odessa, TX.

Fabrication was conducted at Permian Enterprises, Odessa, TX using their standard centrifugal casting production methods (Figure 1) [1]. A variety of different concrete compositions were applied, but all were prepared in a similar manner. The ingredients for all concretes were combined in a mixing bin, then pumped through a delivery lance into the pipe section. The pipe section was capped at one end, and the concrete was pumped through the lance as it was withdrawn. The concrete delivery rate and lance removal rate were chosen to deliver enough concrete for a uniform 12.5-mm-thick (0.5-in) liner in each pipe joint. After charging the pipe section with concrete, the remaining end of the pipe was capped, and the section was loaded onto rollers for the spin-casting operation. Pipe sections were spun at greater than 20g for 1.5 to 4 minutes. This generated forces in excess of 20 g. After spinning, individual pipe sections were removed from the rollers, the ends were uncapped, and excess water and fluid additives were drained from the pipes. This results in a very small water-to-cement ratio. Pipe sections were then kiln cured at 150 °F for approximately 18 hours, except for one calcium aluminate concrete pipe section, which was cured at ambient temperatures  $15\pm5^{\circ}\text{C}$  ( $60\pm10^{\circ}\text{F}$ ).

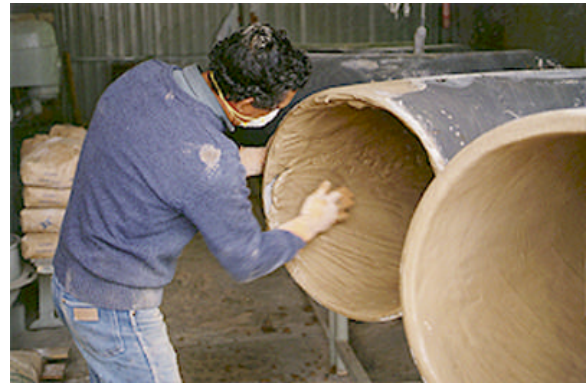
**Figure 2.** Hand-trowel application of an internal concrete liner on a spool piece for the 24" brine header at West Hackberry.

Spool pieces including tees, elbows, flanged sections, and reducers cannot be lined using rotary methods because of their shapes. These parts must be lined by hand (Figure 2). For hand-trowel application, the as-applied concrete mortar contains more water than is present for rotary-applied mortar. After curing, hand-trowelled liners are less dense than liners applied using rotary methods. As a result, these liners are more permeable and have lower strength than rotary-applied liners.

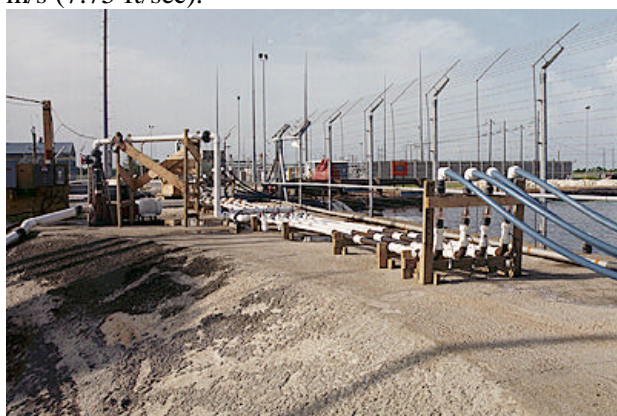
**Figure 4.** The flow-loop test manifold at Big Hill.

The flow loop at Big Hill, shown in Figure 4, used a 1900 L/min (500 gpm) pump to withdraw solution from a brine settling pond and pass it through a test manifold containing the pipe test sections. After passing through the manifold and test sections, the solution was deposited back into the settling pond at a point far removed from the manifold intake. The flow rate in the loop was scaled to create the same pipe-wall shear stress that would be experienced by a 0.92 m (36 in) diameter pipe containing solution flowing at 2.4 m/s (7.75 ft/sec).

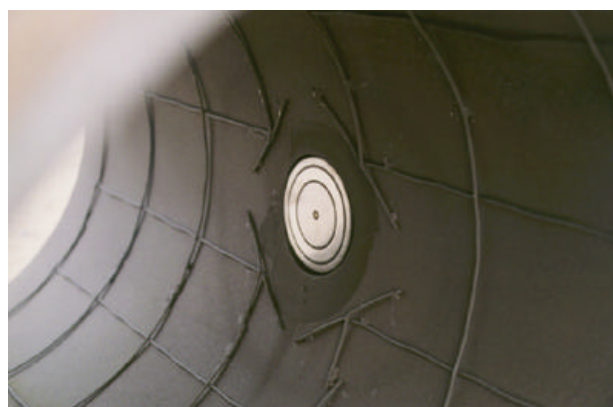
**Figure 10.** An EIS probe installed in a pipe section ready for application of the internal liner.

probes were inserted into these just prior to application of the internal cement lining. Probes were designed so that when fully seated, the sensing surface was flush with the pipe ID (Figure 10).
